## TOP FORM

**The best selling crossover from the Bologna company tackles the hardest reliability test: 50,000 km in only eight months, between March and November 2019.**

**Multistrada has showed its true colours. The jewel on the crown was certainly the engine: between the start and the end of the journey it gained over 4 HP, did not consume any oil and, once we took it apart, its health was perfect.**

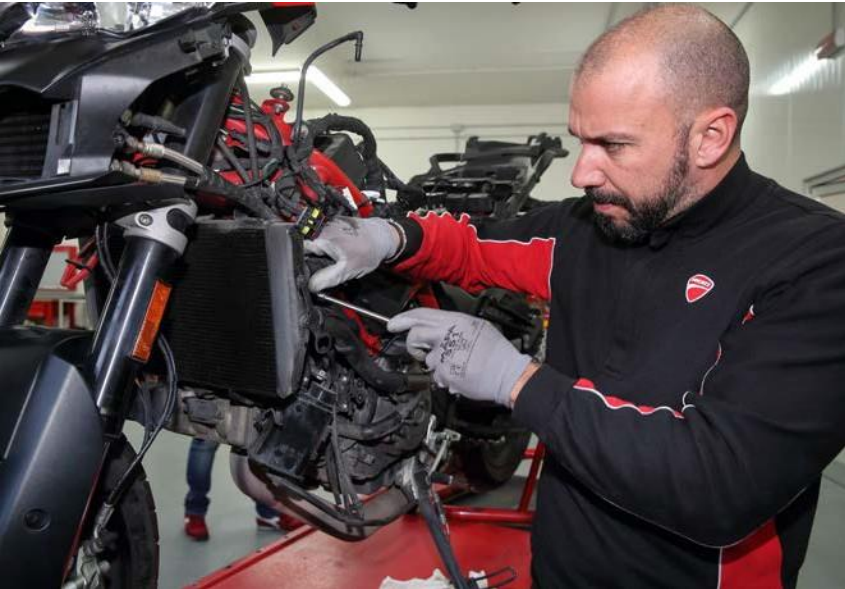
Without a doubt, the engine of our Multistrada is the one in best shape among those taken apart during the previous Long Tests. All the internal parts were found in top shape, with minimum wear. A confirmation of this good mechanical health is the power and maximum torque record values recorded at the end of our test

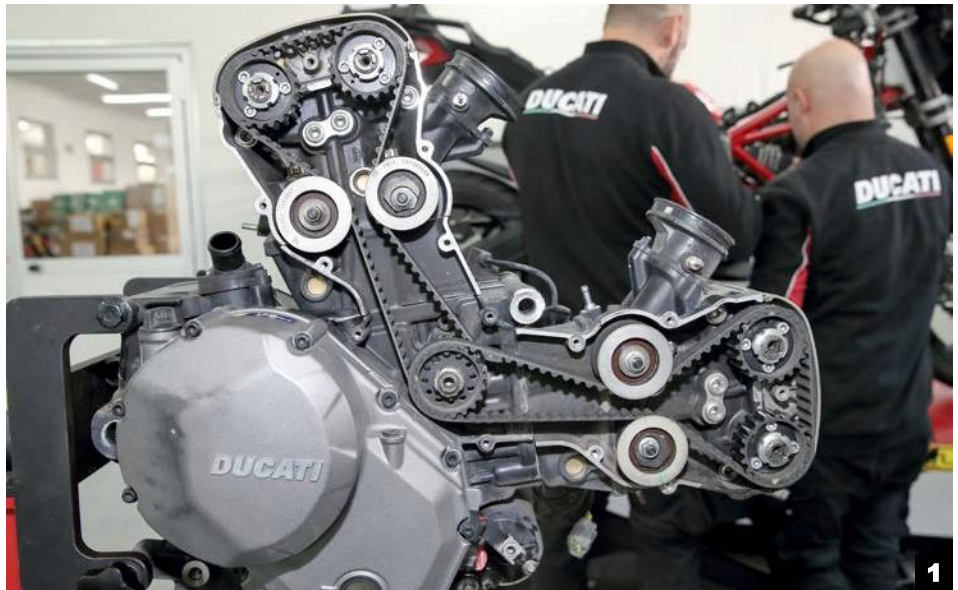
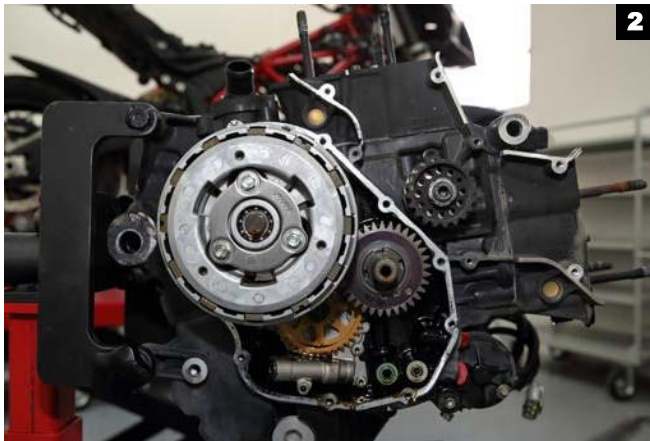
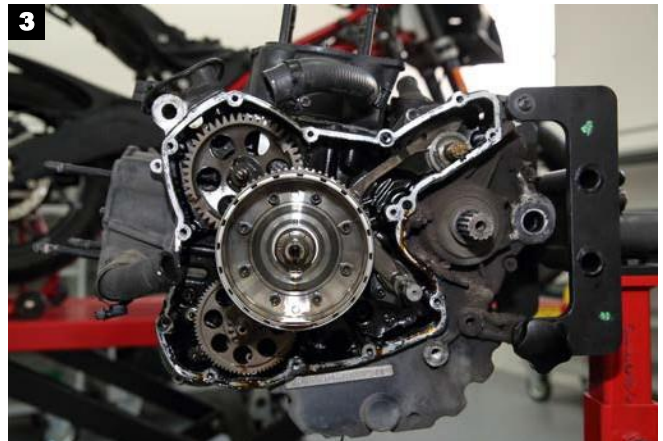
"Our" Multistrada was rapidly reduced to a heap of parts: within one hour the engine was "free". **1.** The twin-cylinder engine is also the load-bearing feature for the front frame. The plastic cover of the timing belts is composed by three parts to facilitate belt inspection and replacement. **2 and 3.** Below is what we saw once the clutch cover (left) and generator cover were taken off. We did not find any residues or sediments in the crankcase.

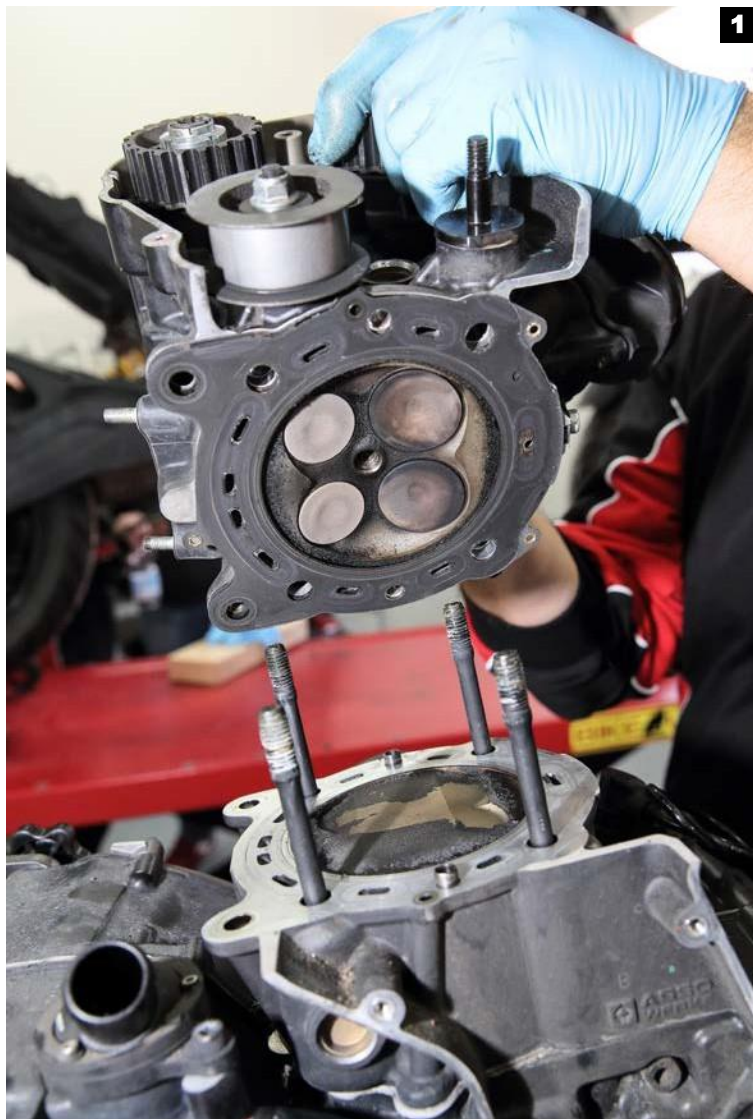
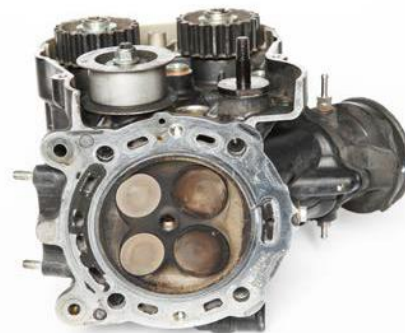
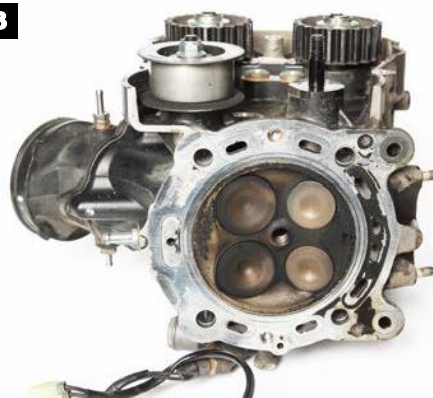
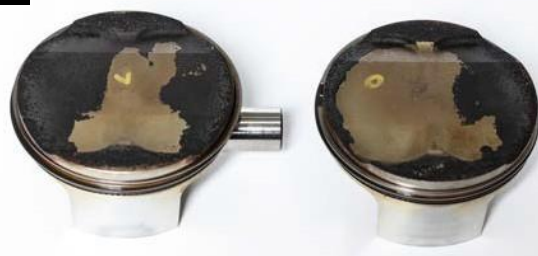
1, 2, 3 and 4. Here's how cylinder heads and pistons looked like. Truly minimal traces of fuel combustion, especially in the vertical cylinder. The reduced traces of carbon residues stems from the relentless research focused on combustion chambers and piston ring profiles, including tolerances

between the piston and the cylinder as well as the valve guide material. All this was confirmed also by a virtually non-existent lubricant consumption, which was never topped up between one service and the other.

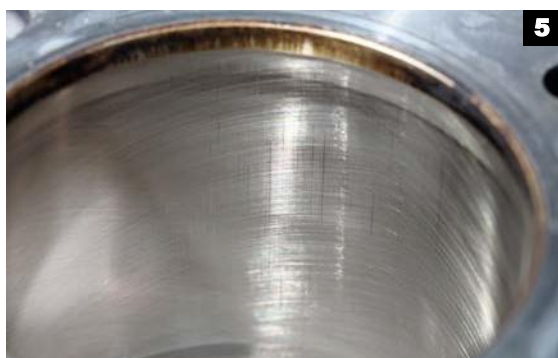
5

5. This is the inside of the vertical cylinder, which only features a few minor scratches that did not affect the performance. Indeed, this engine gave its best in terms of power and maximum torque right after 50,000 km. 6. The conditions of the valves showing traces of unburnt fuel were also within normal ranges.

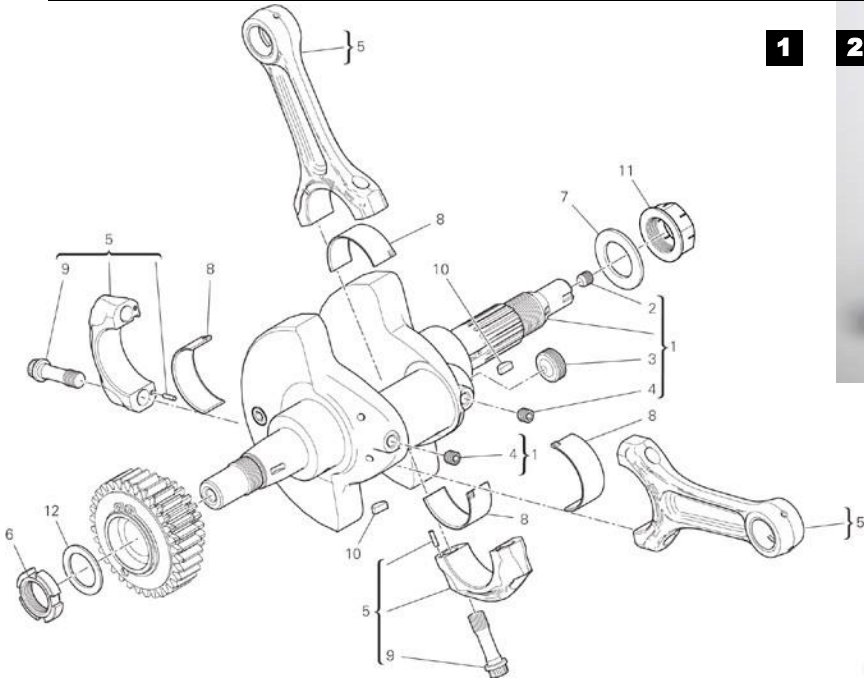
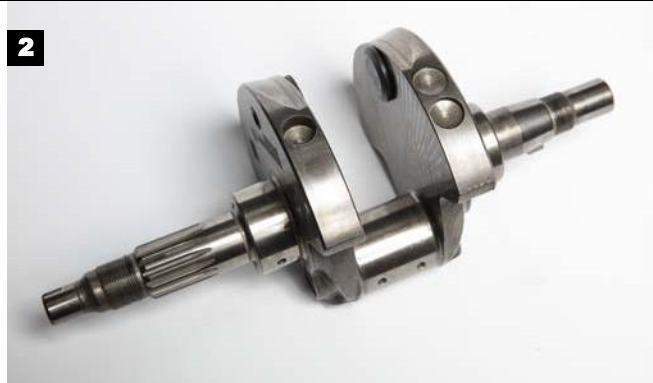
**1 and 2.** Design and real-life picture of the Testastretta connecting rod assy. And the machined areas on the crank webs to balance it. In this case, there is nothing to report, other than the fact that these parts are absolutely in top form. **3 and 4.** The plain bearings ("shells") of the connecting rods and crankshaft were in tip top shape given the miles it ran.

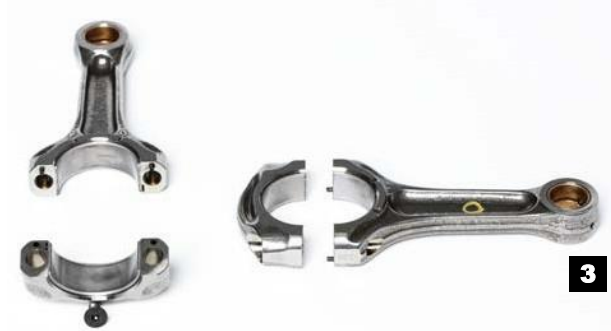
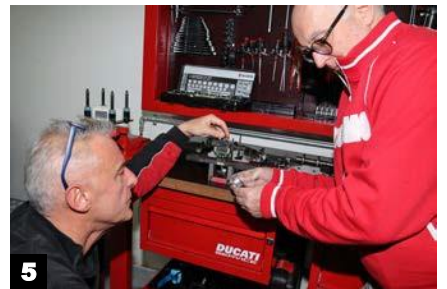
**5.** Measuring the plain bearings carried out under our supervision by technician Roberto Colombarini from the engine development department.

**6.** The gearbox assembly was in mint condition both in terms of the gears and the minimal selector fork wear.

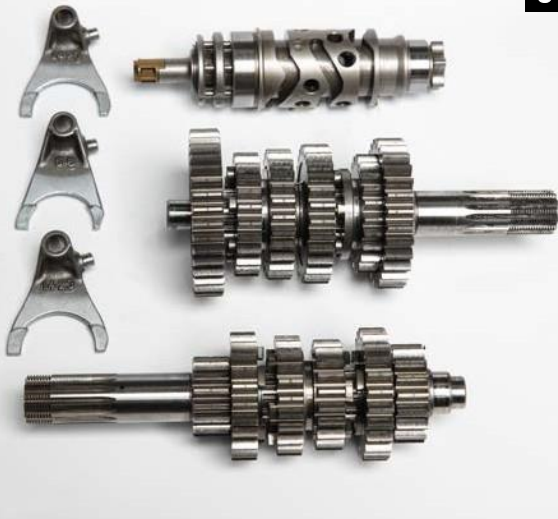
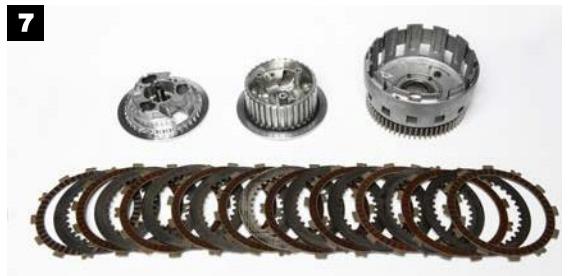
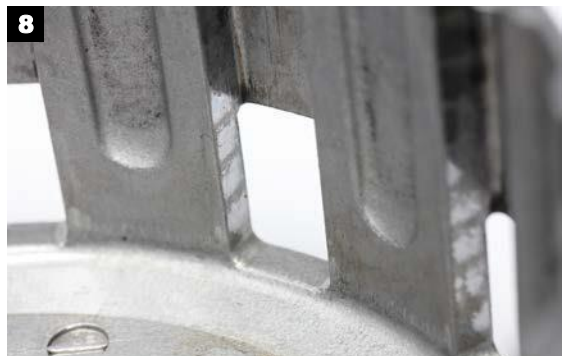
**7 and 8.** The clutch was in good shape with minimum plate wear, while the housing and inner hub were in perfect condition: this is the first time, with all the engines we analysed after our Long Tests, that we do not find any traces of wear or even grooves that prevent the clutch plates from sliding properly.

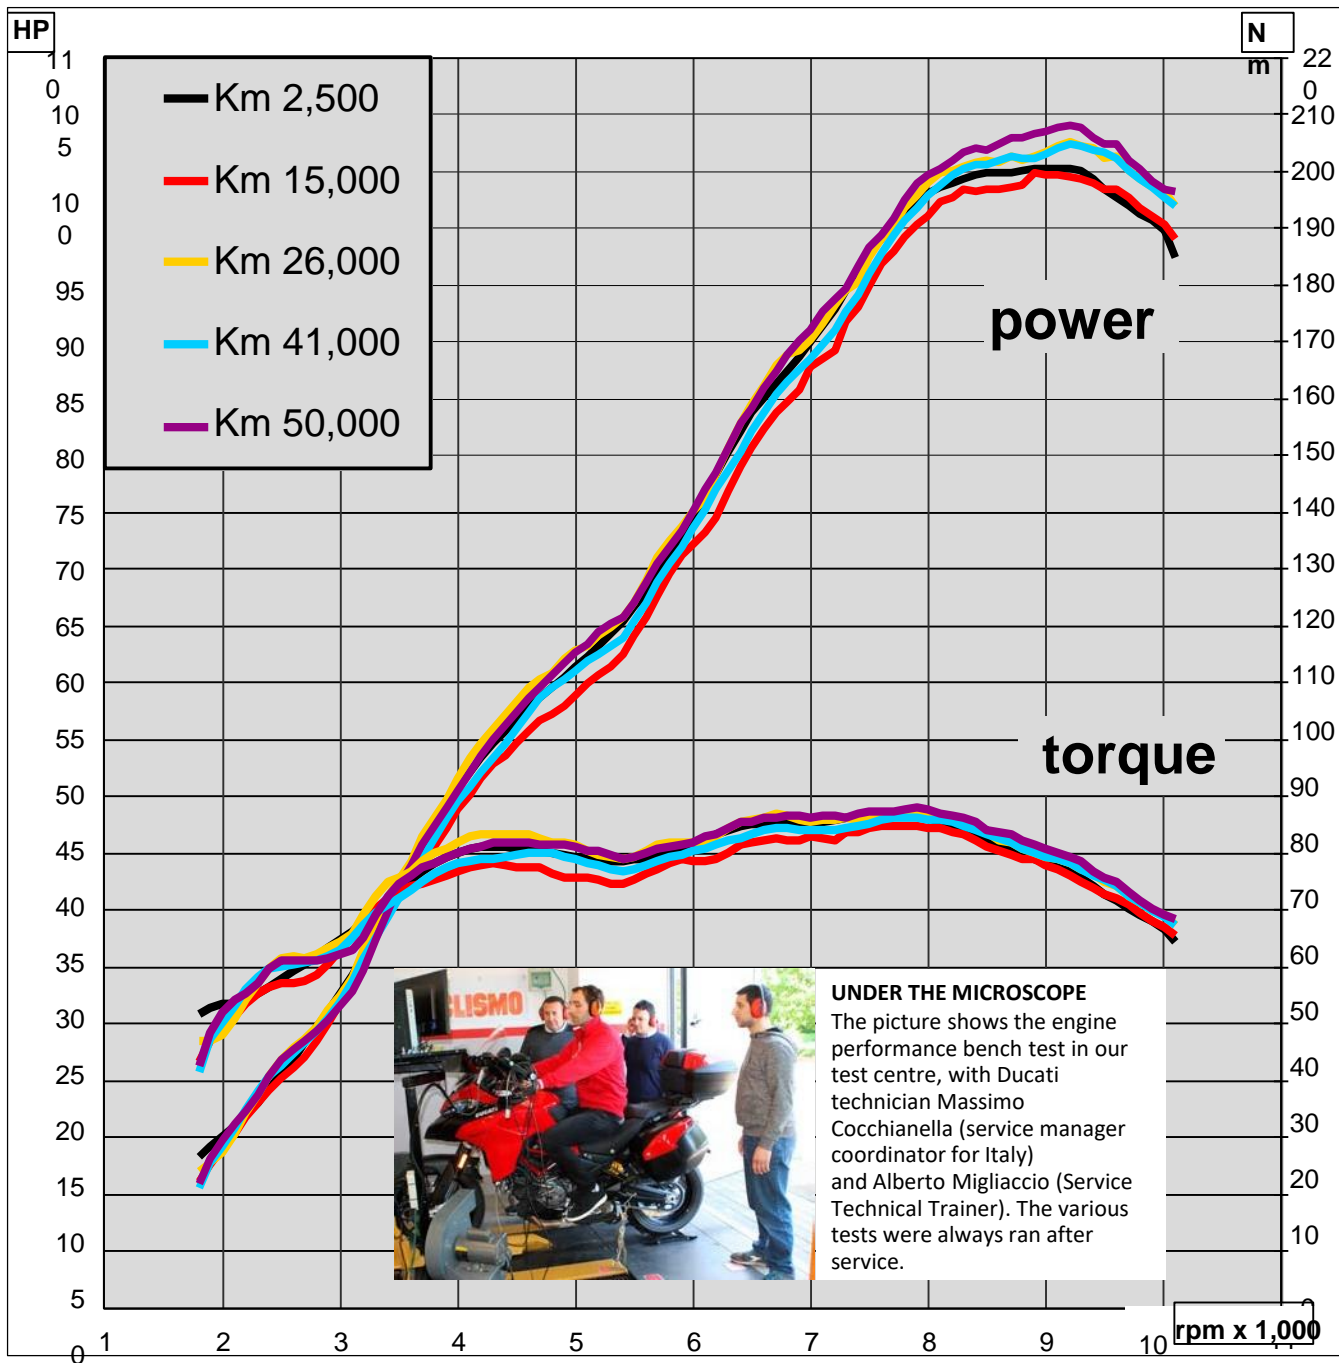
### DYNO BENCH TEST COMPARISON

*The twin-cylinder engine progressively increased its power and climaxed at 50,000 km, a sign of an engine that was in top shape also at the end of the test.*

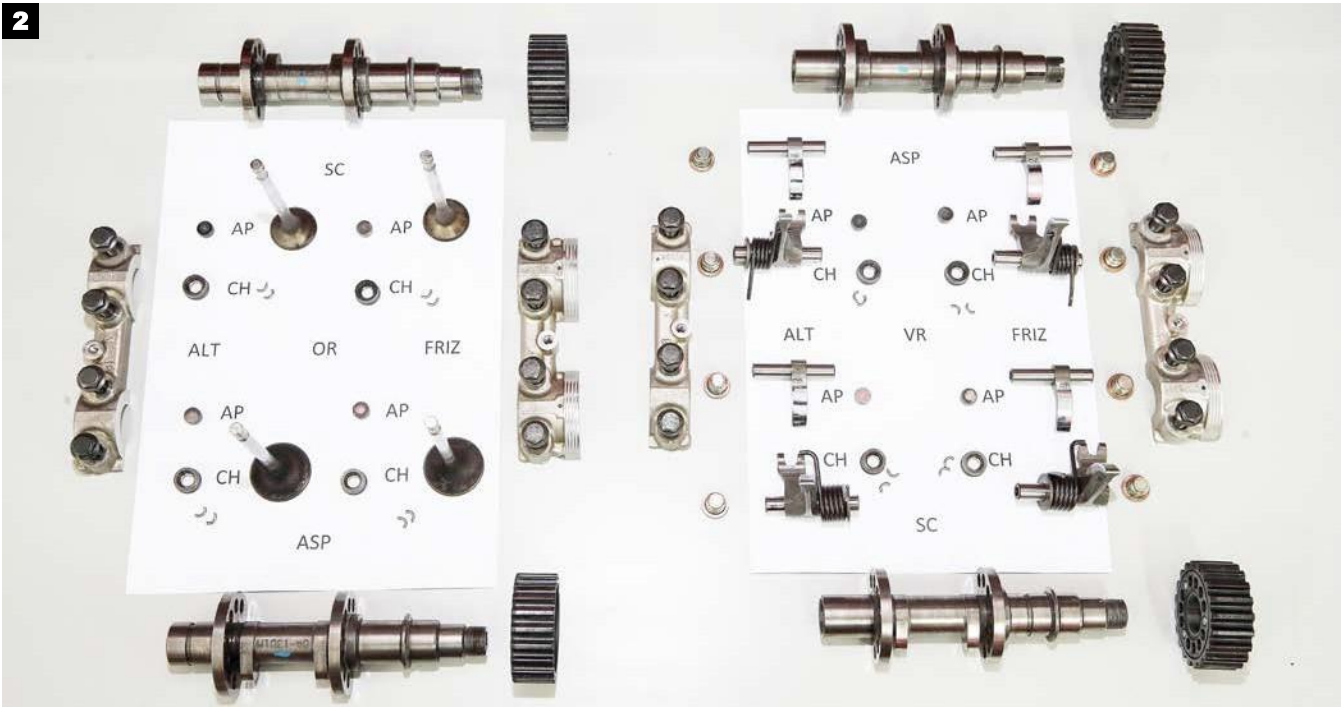
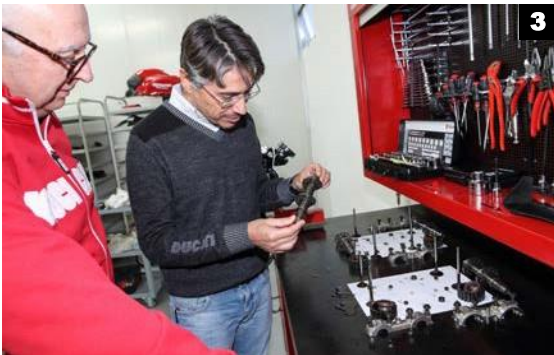
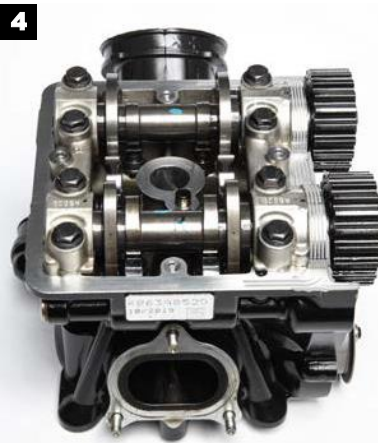
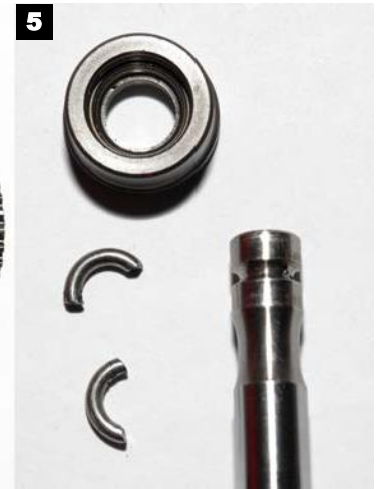
1. Camshafts are driven by toothed belts (another idea by Taglioni, introduced in 1979 for the Pantah 500 engine). They are quieter than other control devices such as chains or gears. They were replaced at the second service coupon.

2. This is Ducati's heart: desmodromic timing system developed by engineer Fabio Taglioni and adopted for the first time on 1956 125 GP. The 4-valve control comes from a project by engineer Bordini in 1987

4 and 5. The rational use of space with the camshafts visibly displayed. At the scheduled check all the operating plays were clockwork. These two tiny steel split rings lock the valves in place.

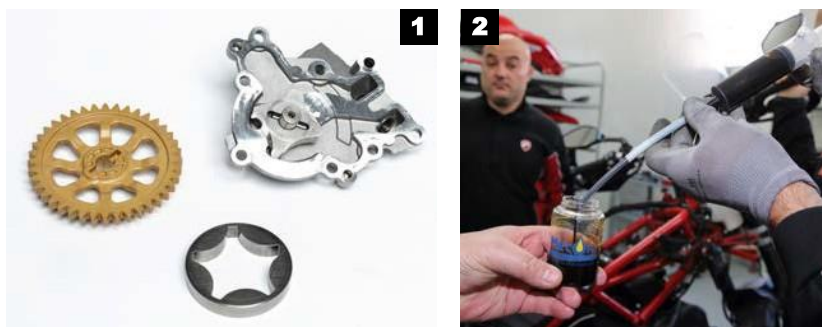
1. The trochoid pump (found in top conditions) and its plastic gear driven by the crankshaft. 2. Lubricant sampling for Mecoil lab. We have not reached the minimum amount of oil during our 50,000 km. In all the other Long Tests, with the exception of the one with Yamaha Tracer 900, we had to top up the lubricant periodically. Below is a summary sheet of lubricant sample results. The decrease in viscosity is compatible with the high mileage endured between oil changes.

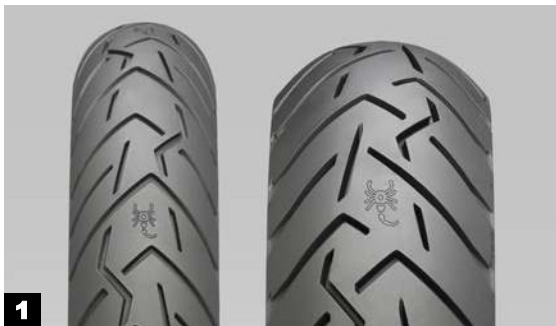
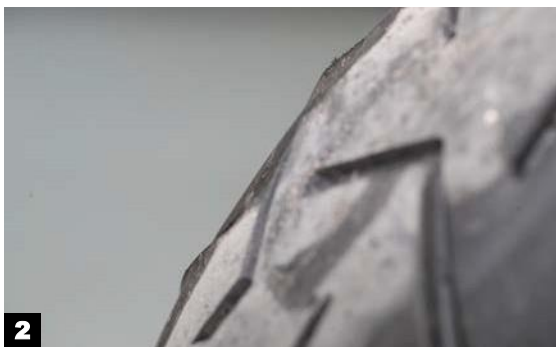
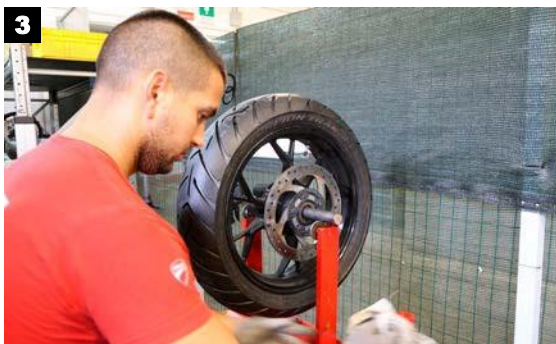
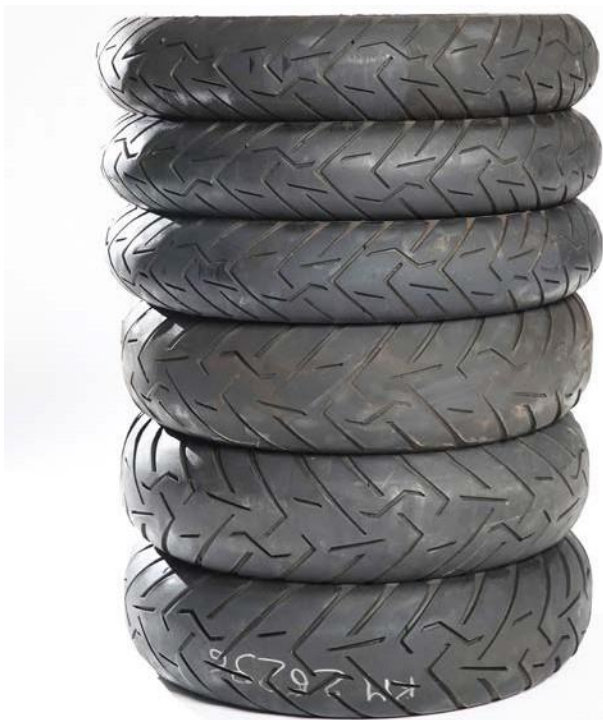
**15,000 KM ON THEIR SHOULDERS. A NOT SHOWING IT**  
Above, 3 tyre sets changed at 15,000, 26,000 and 41,000 km. The fourth was still on the motorbike; with this set we drove the remaining 9,000 km left to reach our 50,000 km goal.

**1 and 2.** The profile of Scorpion Trail II, new and after 15,000 km: as you see, they have a tendency to wear off on the outer side, though we never had any problems in terms of grip or stability, even at this high mileage.

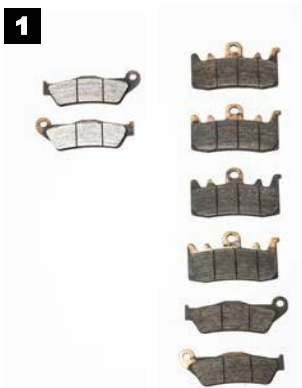
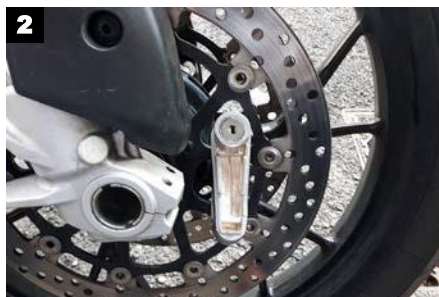
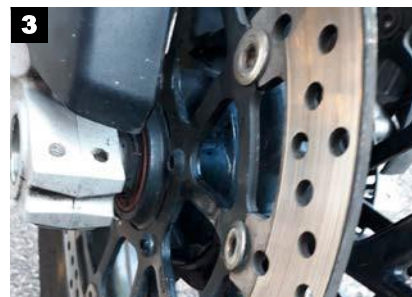
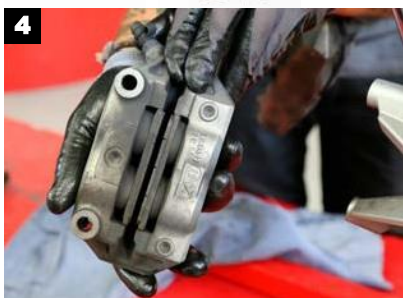
The set of rear brake pads was a bit “soft”, a “theft-proof” disc and two pistons that pushed too much. Nevertheless, the effectiveness of combined braking was always ensured by the very performing Brembo-Bosch combo.

**1.** We changed the rear brake pads at 20,000 km, way before the front ones, which were replaced at 26,000 km. With the second set of rear brake pads we made it to the end of our 50,000 km trip with almost twice as much friction material. This mileage is absolutely within normal range: in other Long Tests the wear was way higher, as in the case of BMW RT, which lasted only 10,000 km. **2 and 3.** On our Multistrada we had to change the right front disc at 21,500 km because the hub connection flange bent because of an attempted theft. The disc lock did its part and the Multistrada was saved; even though the light alloy flange causing the disc to float did not break, it took quite a hit and was damaged. **4.** A higher wear in the outer brake pad is worth mentioning, as compared with the inner brake pad, in the front right calliper. This had no connection with the attempted theft, because this issue came out since the beginning of the test. Most probably this is due to the pistons on that side of the radial calliper: they do not run immediately back into their housing as the brake lever is released on the handlebar and keep pressing (though slightly so) on the brake pad.

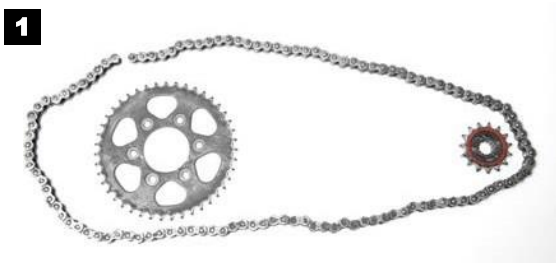
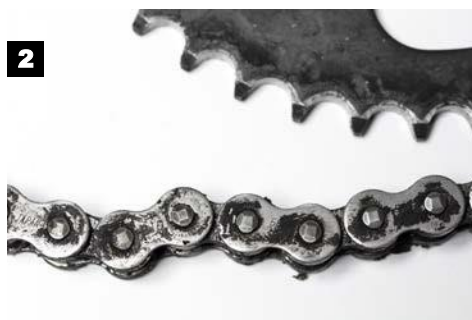
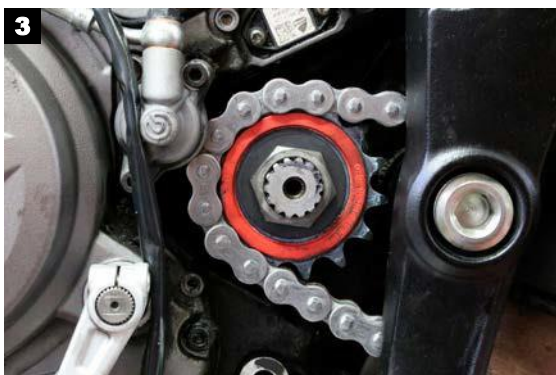
**1 and 2.** At 26,000 km we replaced the original final drive. It was a precautionary measure given the unknowns of a long journey across Europe. Actually, the time was not right to change the chain (DID 525 HV3), even though two or three links were beginning to show some signs of seizing; as concerns stretch, we were well within the limits. **3.** Front and rear sprocket conditions were good. The second final drive kit, also a Ducati genuine part, made it to the end of the test (24,000 km) and was still “in shape” then. With an instrument we monitored chain efficiency in terms of stretch and we measured a residual “life” close to 80%. As a spare part, the chain, front and rear sprocket set costs 232 Euro.

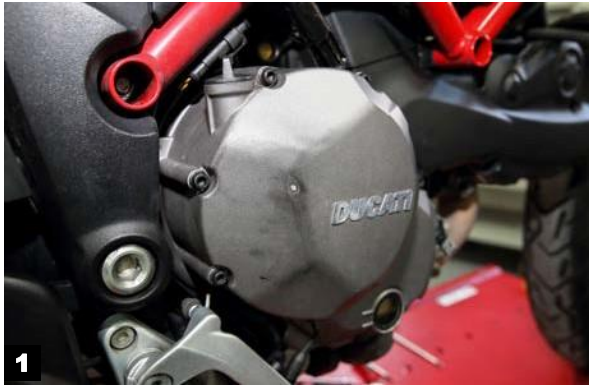
▲ The bolts, the various steel or light alloy components showed no signs of oxidation. With the exception of the right crankcase, at the clutch cover area, which was worn due to the contact with the boot, the bodywork, engine and frame paint was in top shape

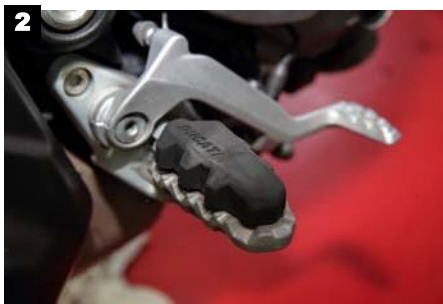
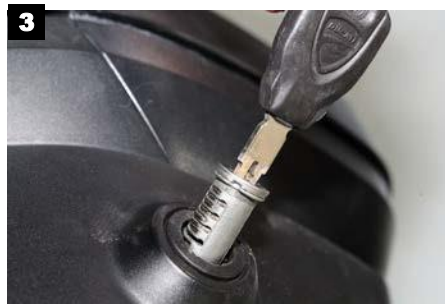
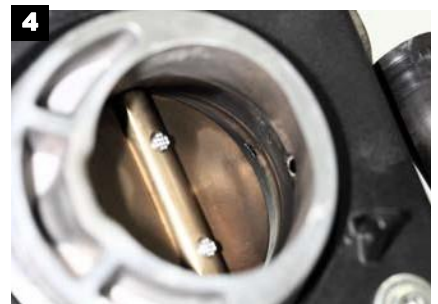
▼ A certain hesitation at idling (only at the end of the test), a lock that comes off and the footpeg rubber covers that came off.

If the Multistrada engine did not fail us as far as use and - as we explained in the previous pages - health conditions go, a few exceptions to the more than satisfactory Long Test of this versatile bike from the Borgo Panigale brand came from the clutch cover paint (1) that came off quite rapidly because of the contact with my right boot, and the footpeg rubber covers (2) which are press-fitted onto the footpegs and come off quite soon: we lost four of those. The side plastic panniers are easy to fit and remove, and absolutely waterproof, though at the end of the test the lock came off (3) from the left pannier.

Towards the end of our test the engine occasionally showed a few hesitations while riding in the city at low rpm: a small carbon residue on the outer circumference of the throttle valves in one of the throttle bodies (4) prevented the valve from closing properly. No issues were recorded any more when opening more the throttle control.

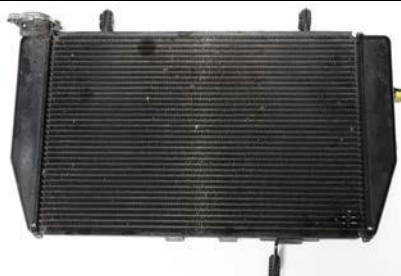
5

5. At 39,483 km the cooling radiator got punctured; an object, probably a rock shot out by the front wheel, opened a hole in one of the tubes where the fluid flows. Fortunately the hole was quite small (with minimum fluid loss), and we were not far from the next scheduled stop. It was subsequently replaced by Ducati technicians. 6. The "heart shaped" exhaust system is almost hidden to the sight taking up the rear space behind the engine. The front exhaust manifold, the one exposed to the elements, showed surface oxidisation, though less than in other previous Long Tests, specifically those involving Honda Africa Twin, Kawasaki Versys 650 and Yamaha Tracer 900. The silencer coating also withstood the test.

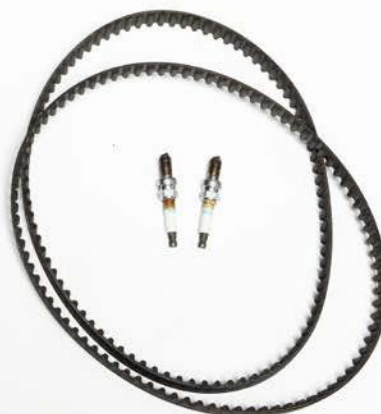
41,000 KM

All maintenance operations were provided directly by Ducati Service in the company and performed by company technicians, attentively followed by our people from the test centre as well as the journalists from *Motociclismo*. This was a good opportunity to appreciate the painstaking care for improving the quality of the motorbikes made in Borgo Panigale. Moving the frequency of the services to 15,000 km (now coupled with a 4-year and unlimited mileage warranty for the Multistrada family) is certainly a sign that the company is absolutely confident about this product. The cost of Multistrada servicing was 1,457 Euro, which includes 11.5 hours of labour, 13,6 litres of lubricant, 4 oil filters, 1 air filter, two timing belts, two spark plugs, 2,4 litres of coolant, 1.38 litres of fork fluid. The most expensive service was at 30,000 km (which we advanced to 26,000 km for logistical reasons; as a consequence the 45,000 km service, too, was performed earlier at 41,000 km in order to comply with the 15,000 km limit) where, besides changing the oil and the oil filter, the valve clearance must be also checked, together with engine oil inner filter cleaning, timing belt replacement and new spark plugs and air filter installation.
